# Photographing Historic Structures: Guidelines and Photo Logs

Prepared by the Illinois Department of Transportation  
Bureau of Design and Development  
Cultural Resources Unit

# **Photographing Historic Structures: Guidelines and Photo Logs**

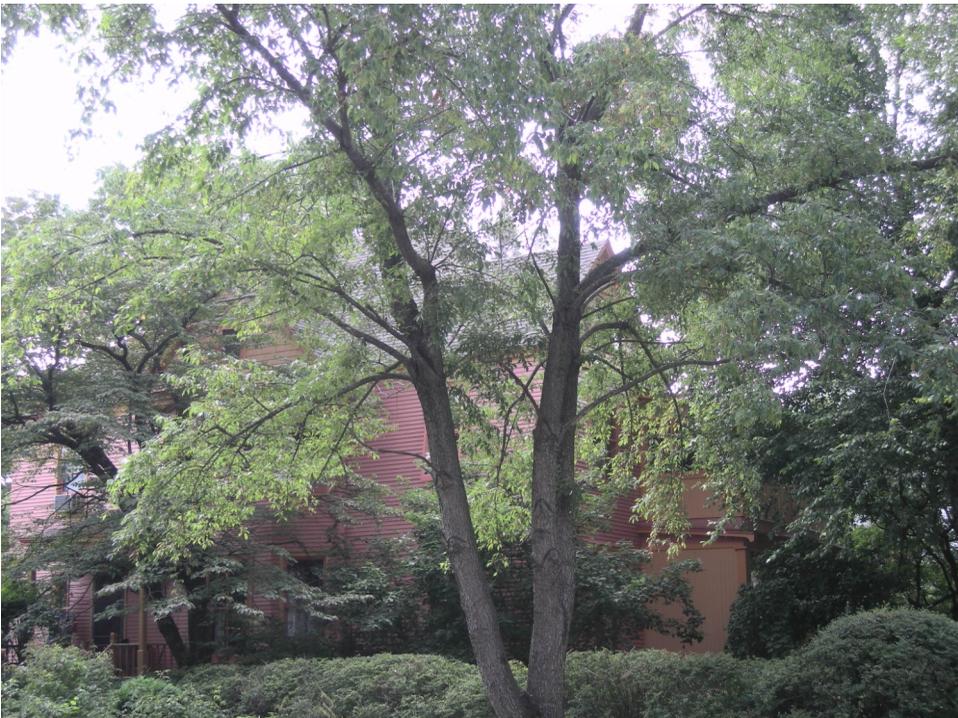
This house is too obscured by foliage during the summer to allow a clear photograph to be taken. Waiting until winter before taking the photo may alleviate the problem.

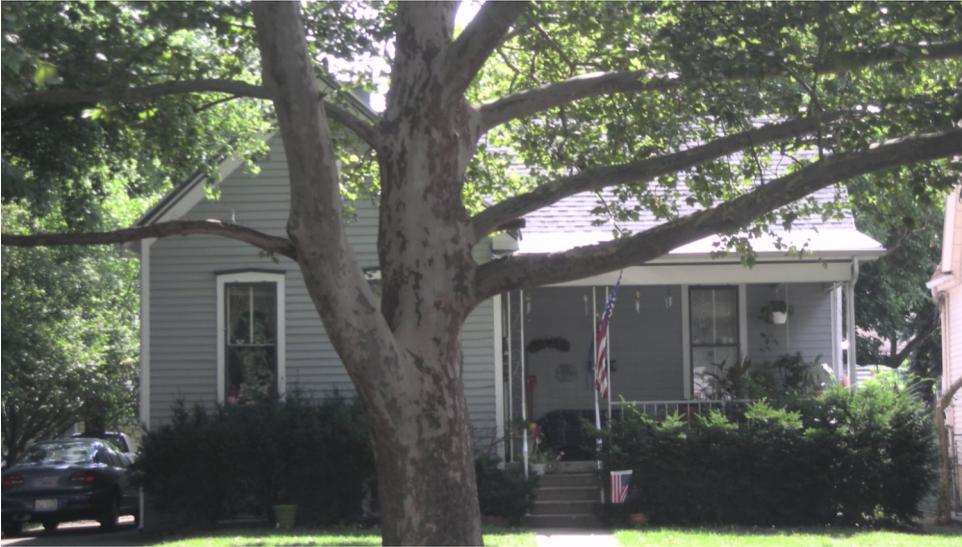
The large tree in this photo obscures the house and makes it difficult to see important details.

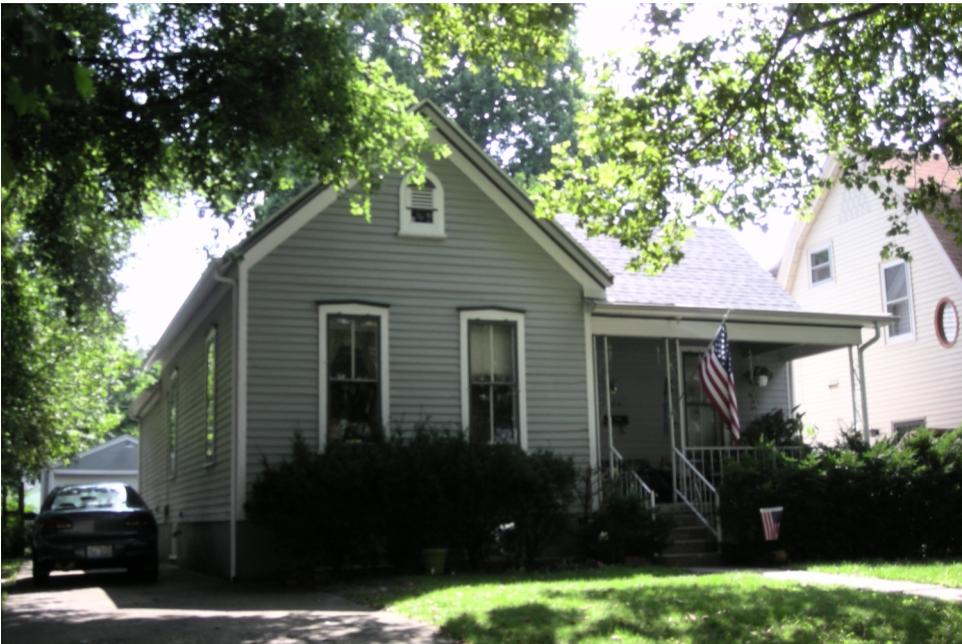
By simply moving several feet down the road, the house can be photographed from a slightly different angle allowing a clearer view.

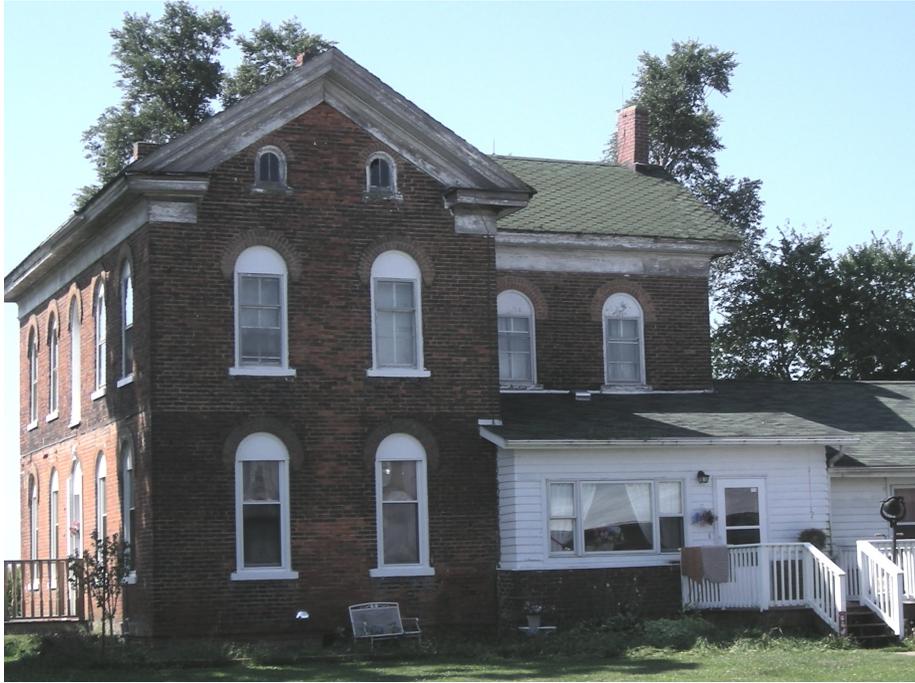
The top photo is of a vernacular “composite” house with some Greek Revival elements. The primary style characteristics of this house include the wide band of trim with turned cornices in the gable.

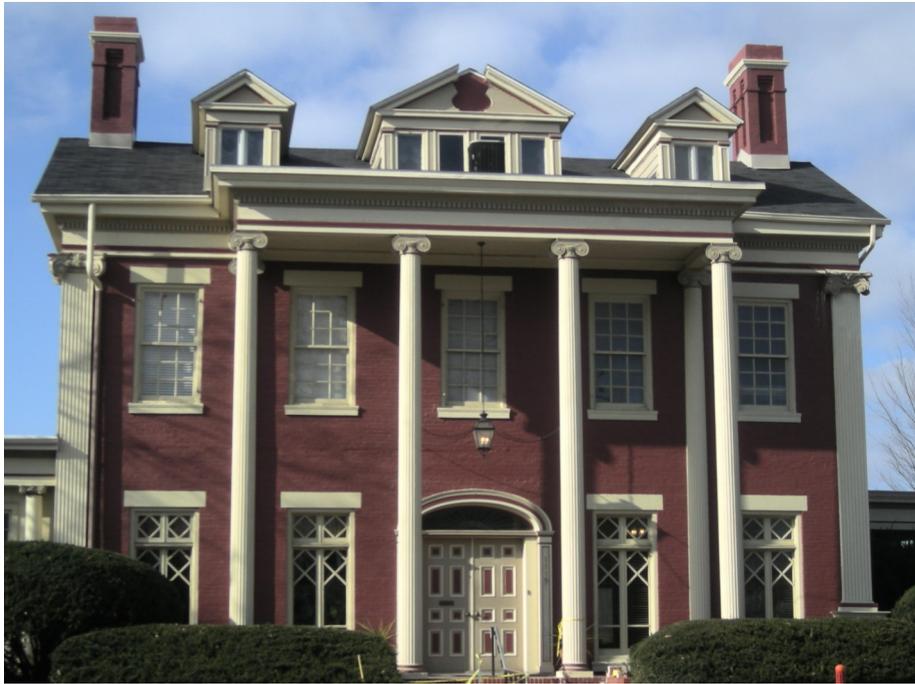
The bottom photo is of a house that exemplifies the Neoclassical style. Note the wide band of trim below the roofline and the accentuated pilasters at the corners. This house also shows a full-height porch supported by classical columns.

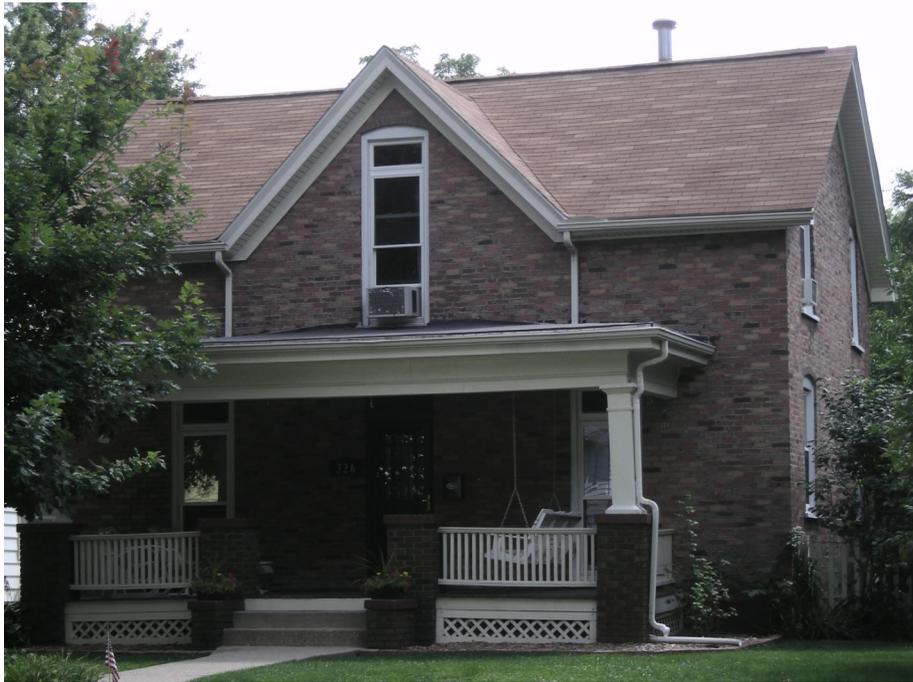
The top photo shows an example of a vernacular Gothic Revival house. Note the steeply pitched side-gabled roof with a central cross gable. The center window is tall, narrow, and extends into the cross gable. The porch is a later addition built in the early 20th century.

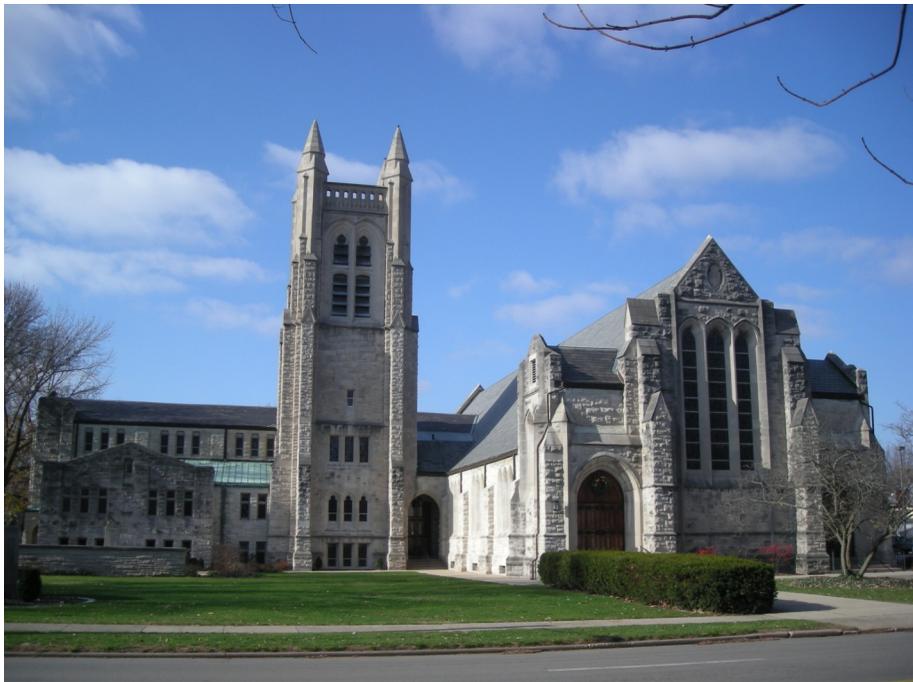
The bottom photo is of a Gothic Revival church. It is reminiscent of the Gothic churches in Europe, where the style originated. The building has the characteristic pointed Gothic windows, rusticated stone, and the tower has parapets.

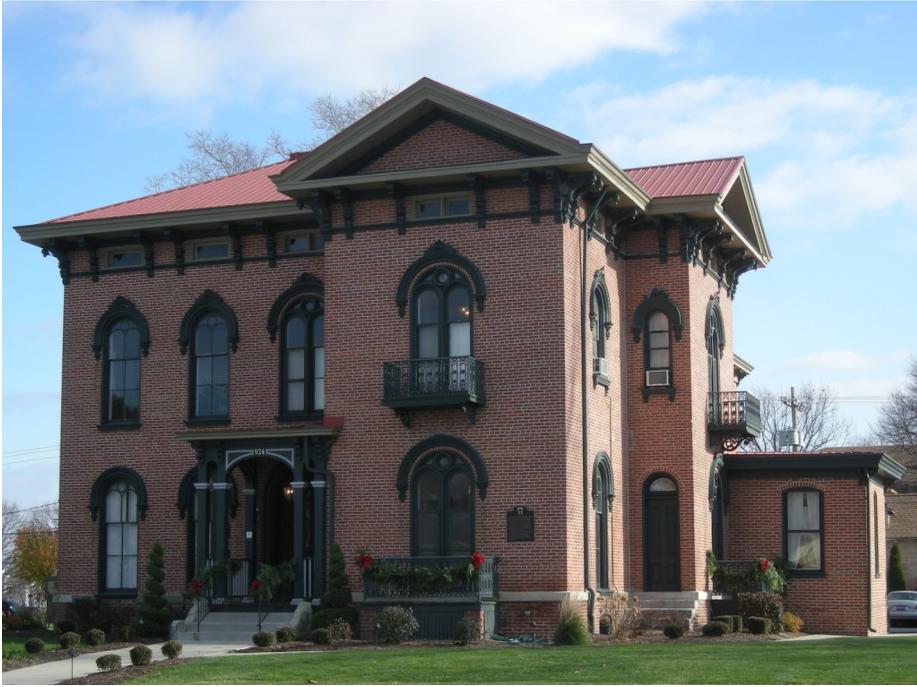
The top photo shows a two-story Italianate house. The pitch of the roof is low with widely overhanging eaves supported by large brackets. The windows are tall, narrow, and rounded at the top. Inverted U-shaped hoods decorate the tops of the windows.

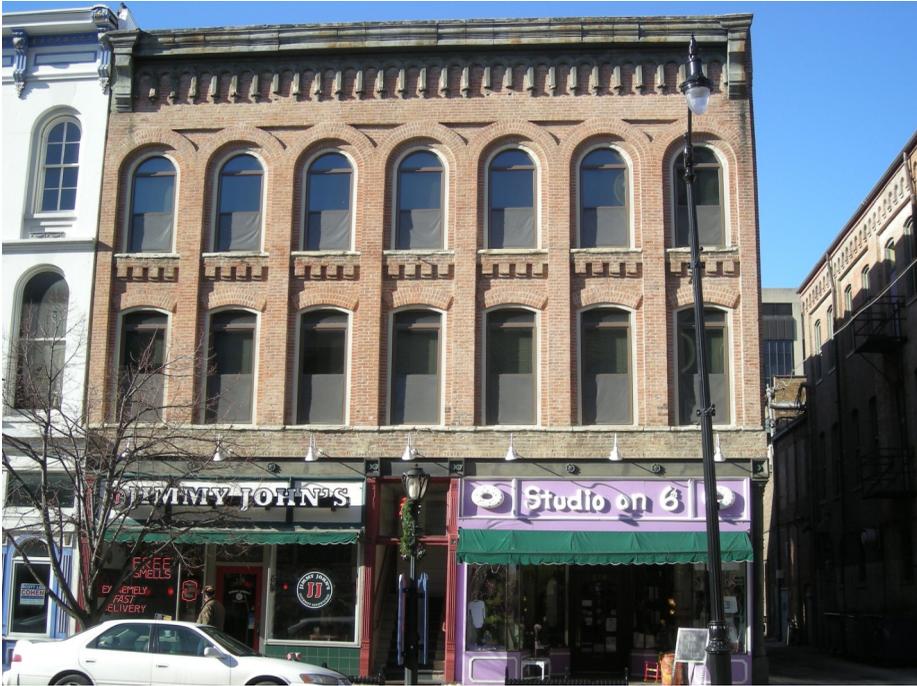
The bottom photo is of a Italianate commercial building. The building has a flat roof with an emphasized cornice. Mock brackets made by protruding bricks are under the cornice. The windows are tall and narrow with curved tops. The second story windows have brick hoods over them.

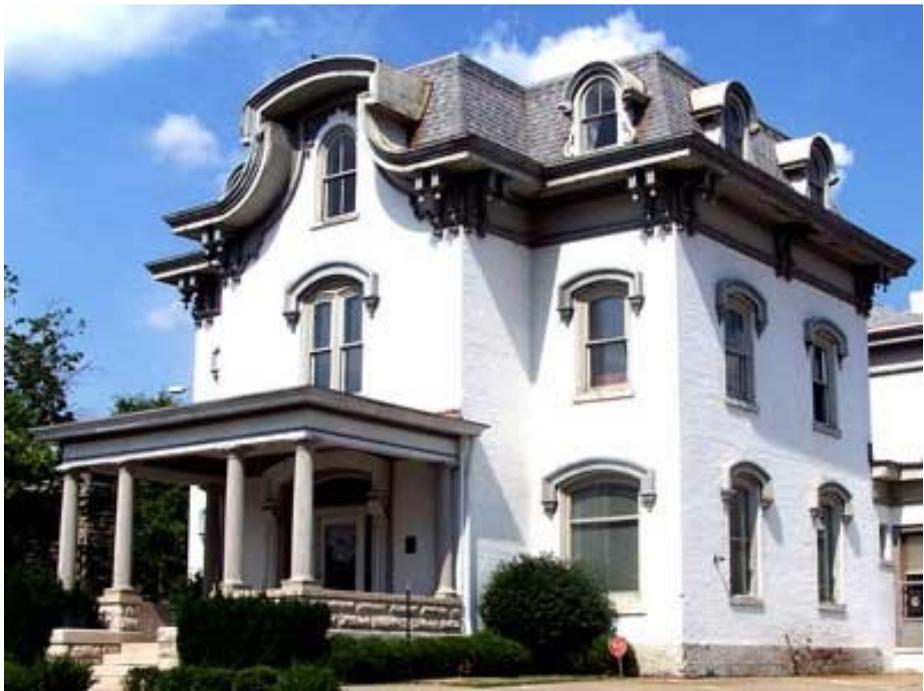
The top photo shows a three-story Second Empire house. The mansard roof has widely overhanging eaves above decorative brackets. The windows have rounded tops covered by decorative hoods. Dormers are present on the steep lower slope of the roof.

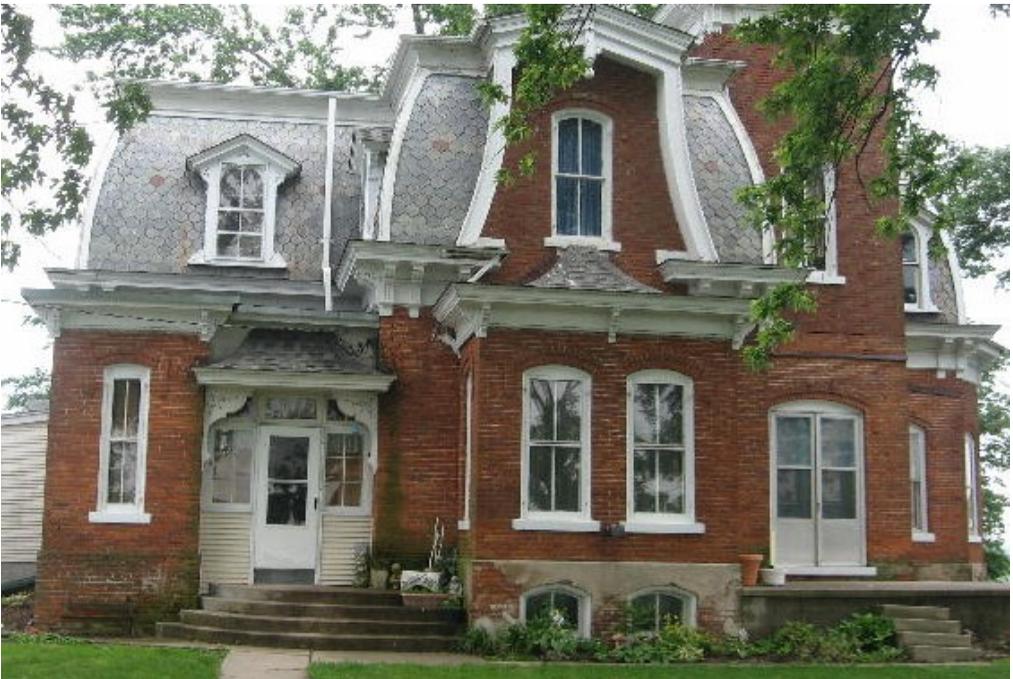
The bottom photo is of a Second Empire house where the main focal point of the building is the patterned mansard roof. Heavy molded cornices bind the top and bottom of the lower slope of the roof. Decorative brackets are beneath the overhanging eaves. The windows are tall, narrow, and have curved tops. Subtle hoods created in the brick pattern cover the windows.

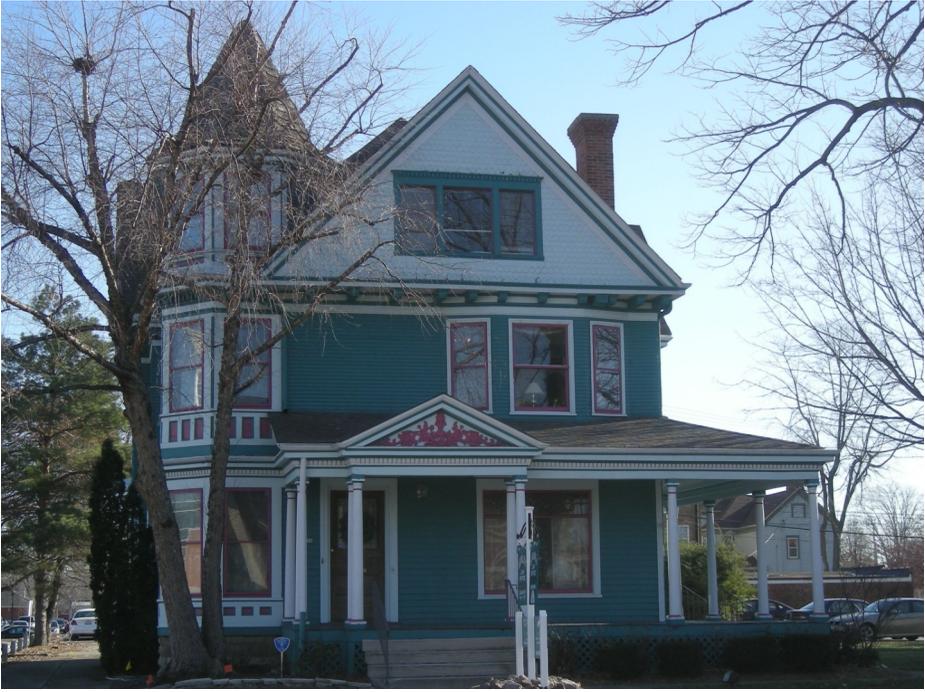
The top photo shows a Queen Anne house that illustrates many of the features of the style. It has a steeply pitched roof with a front facing gable. Flat wall surfaces are minimized by a number of elements: bay windows, the tower with patterned trim, and decorative shingles in the gables. A one-story porch spreads across the front of the house and wraps around the side wall.

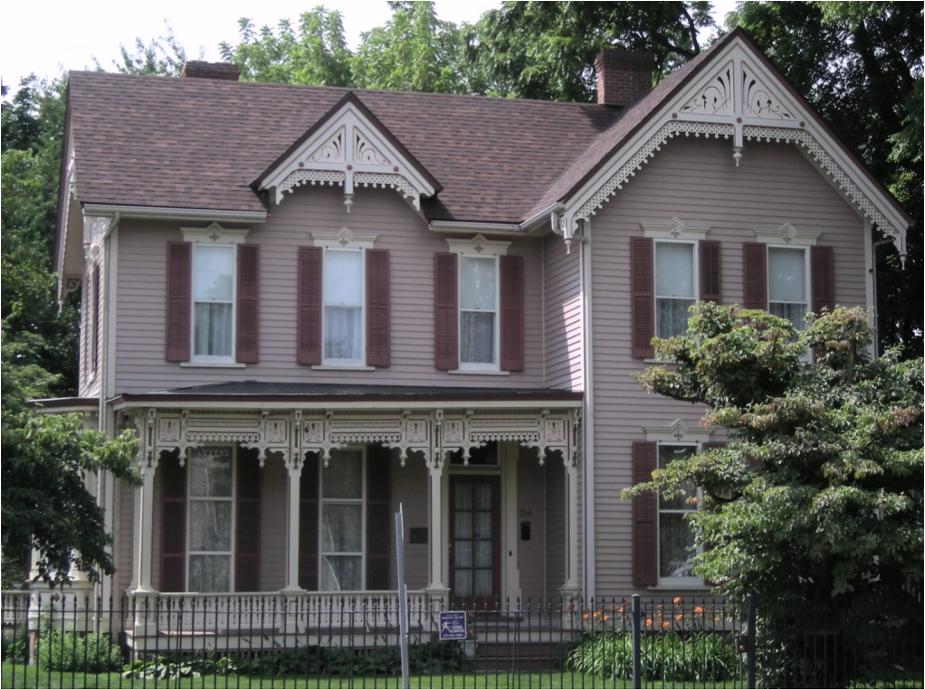
The bottom photo is of a house with Queen Anne detailing. The decorative woodwork in the gables and the porch illustrate the Queen Anne influence on this building. Other influences, such as Italianate (the windows) are also evident.

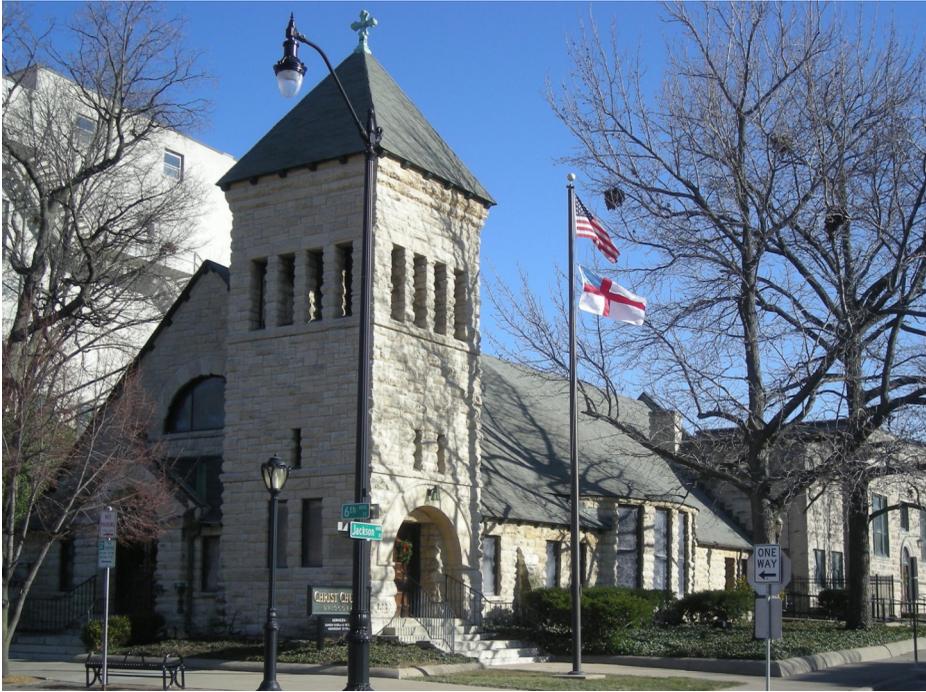
The top photo shows a church that displays several Richardsonian Romanesque characteristics. The walls are comprised of rough-cut or “rusticated” squared stone. The entrance and the window above the entrance have rounded tops. The façade is asymmetrical with a tower.

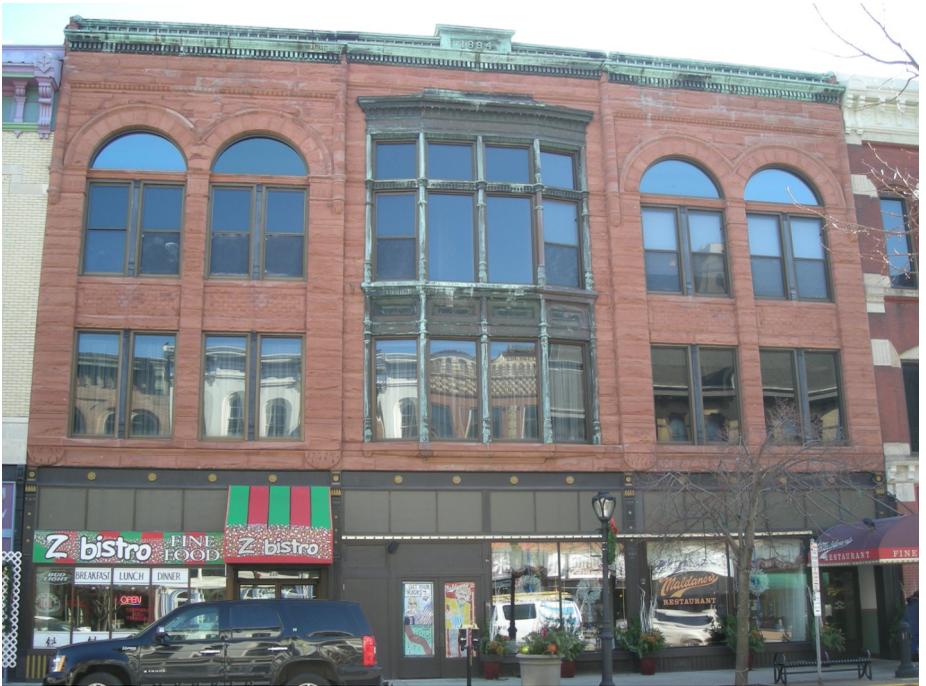
The bottom photo is of a Richardsonian Romanesque commercial building. The façade is rusticated stone. The windows are topped with round arches. Unlike many Richardsonian Romanesque structures the façade on the building is symmetrical and has copper accents.

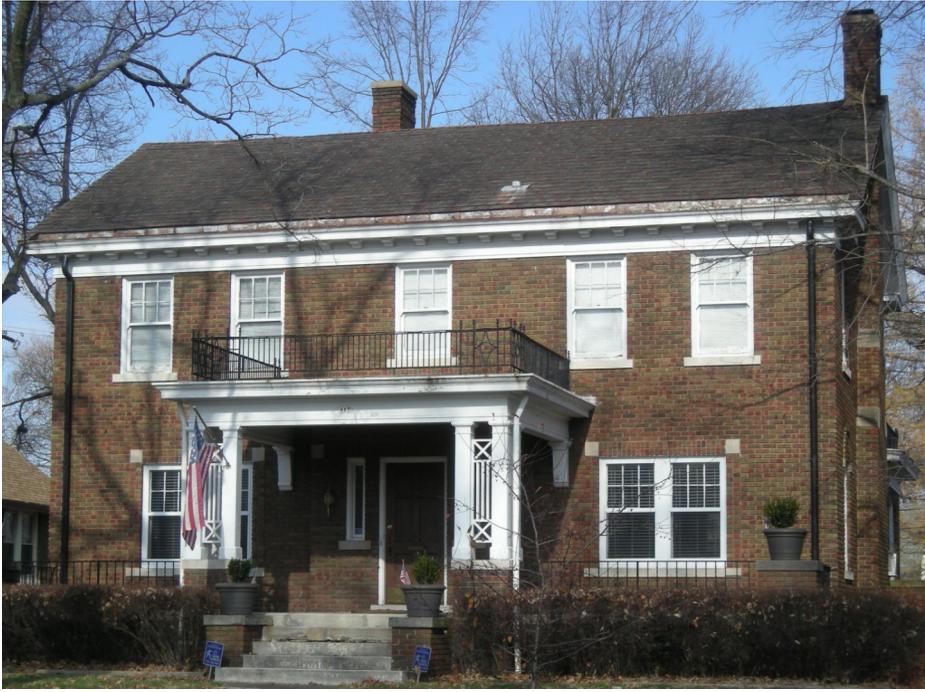
The top photo shows a two-story Colonial Revival house. The front door is accentuated by the front porch. Sidelights flank the door. The windows are symmetrically balanced with the first floor windows in adjacent pairs. The glazing in the windows are in a multi-pane configuration in the top sash.

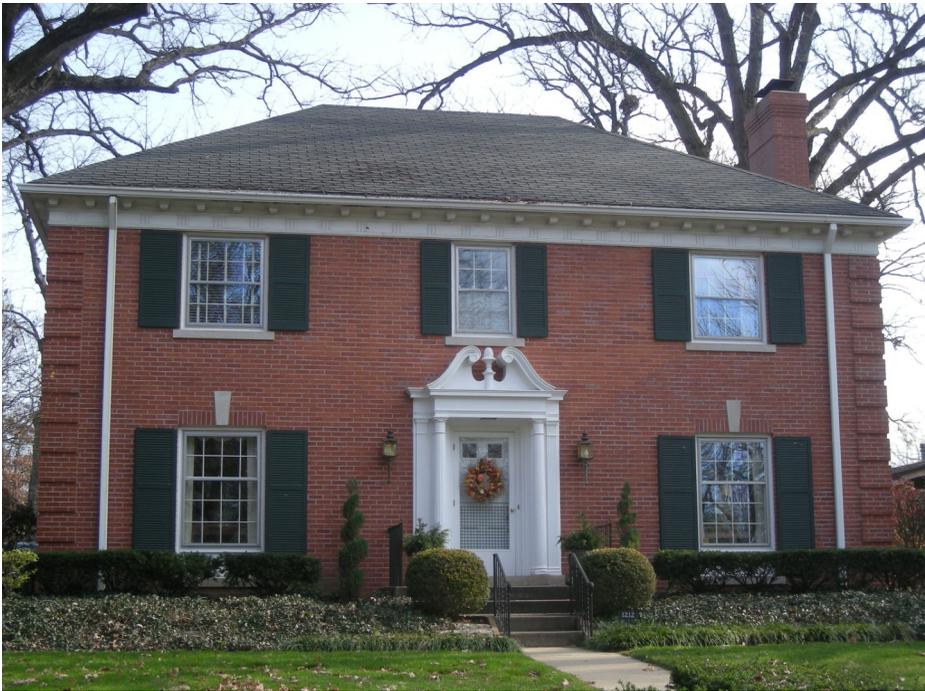
The bottom photo is of a house that is also a two-story Colonial Revival. A pediment supported by pilasters accentuates the front door. The windows are symmetrically placed with multi-pane glazing in both sashes.

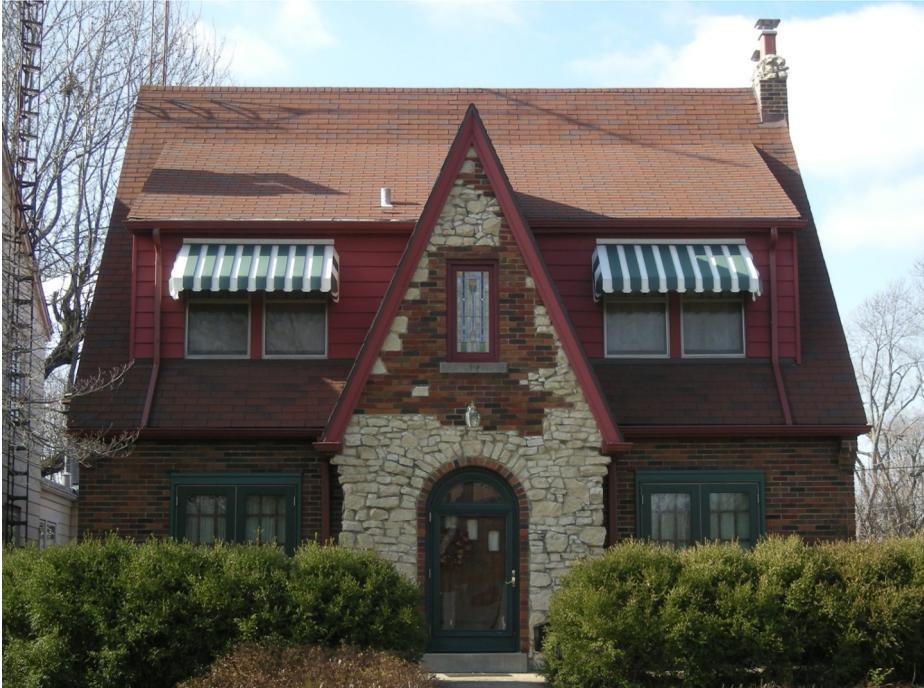
The top photo shows a Tudor Revival house with a steeply pitched side-gabled roof and a front facing steeply pitched gable entrance. The gable and first floor windows are tall and narrow with the first floor windows in groups. The entrance façade has a combination of brick and rusticated stone. The chimney is crowned with a decorative chimney pot.

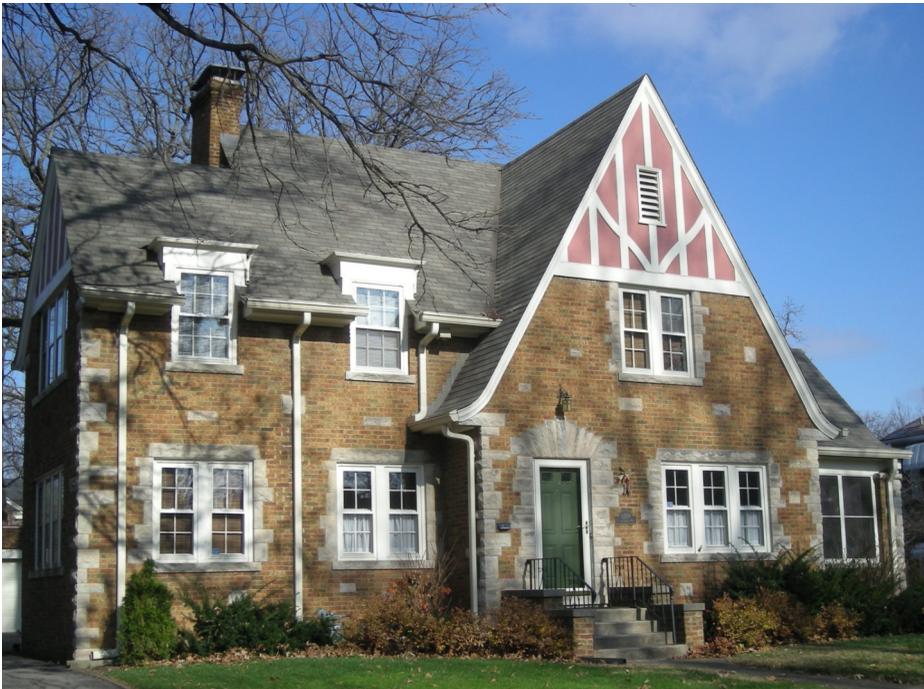
The bottom photo is of another Tudor Revival house showing the characteristic side-gabled roof with a prominent cross gable. Note the decorative half-timbering in the peaks of the gables. The windows are tall, narrow, multi-paned, and grouped. The brick façade has rusticated stone strewn throughout it and on the corners where the walls meet.

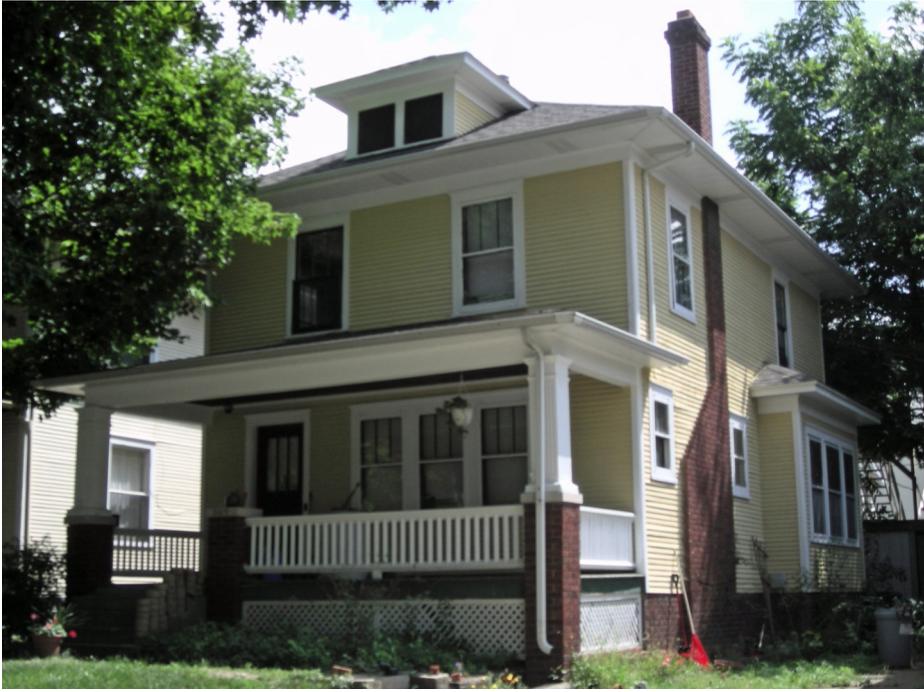
The top photo shows a two-story Foursquare house with a pyramidal roof and overhanging eaves. A dormer projects from the center of the roof above the façade. The house has roughly a square floor plan and a full-width front porch. The porch is supported by columns atop pedestals.

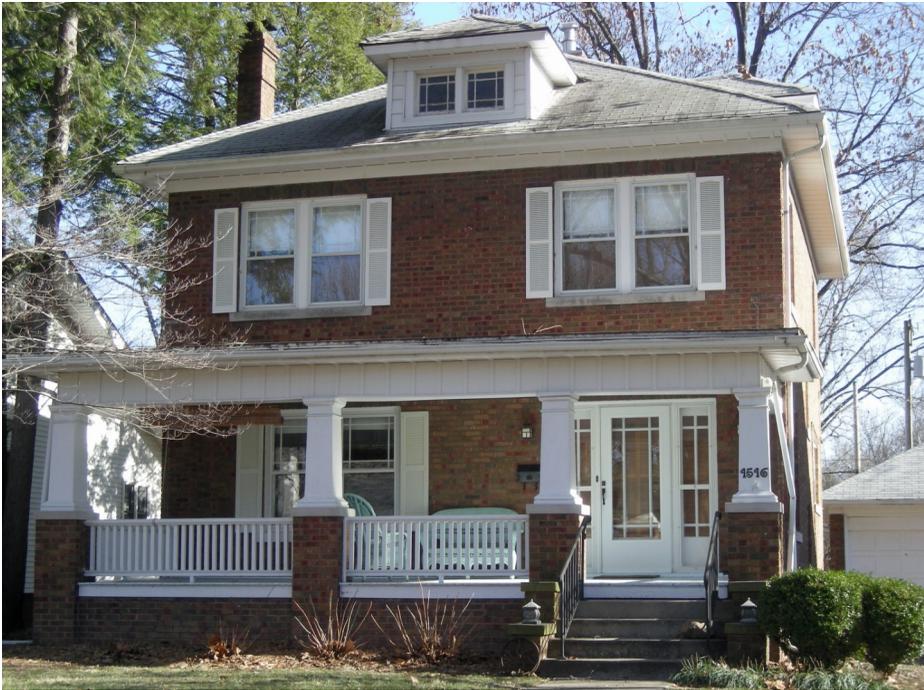
The bottom photo is of a Foursquare house with the characteristic two stories and pyramidal roof. Dormers are present on the front and side roof slopes. The house has a square floor plan with a full-width front porch supported by columns atop pedestals.

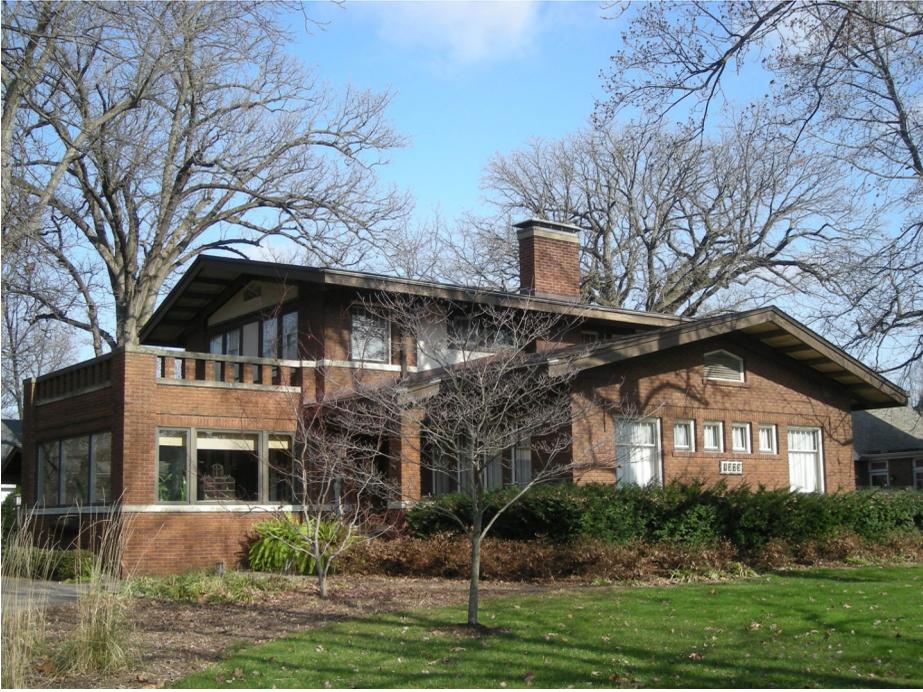
The top photo shows a Prairie style house with low-pitched gable roofs. There are several one-story wings and porches coming off of the main mass of the house. The low pitches of the roof lines and the façade detailing emphasize the horizontal. The enclosed porch is supported by heavy square elements.

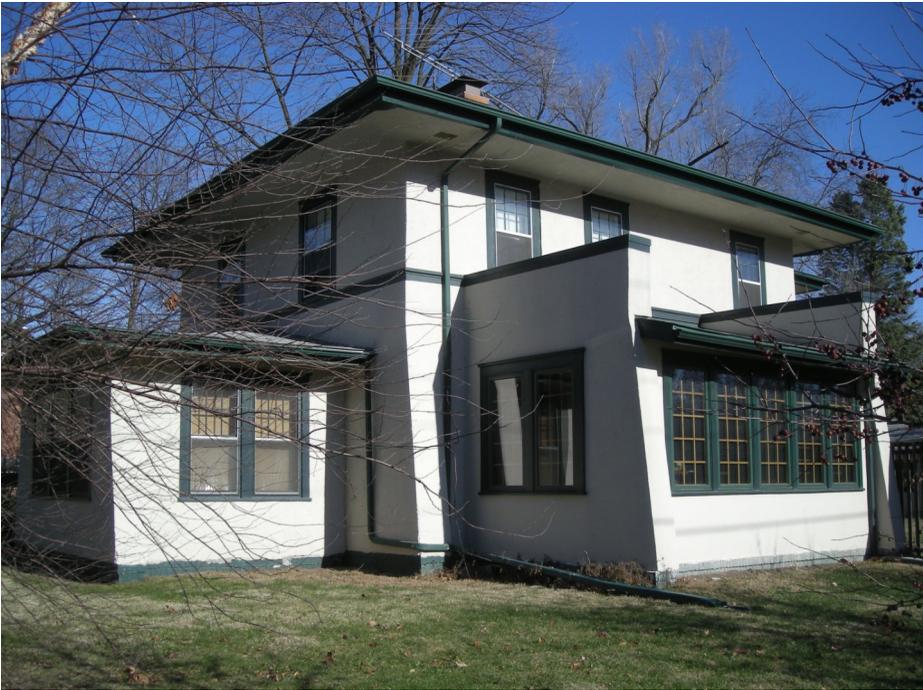
The bottom photo is of a Prairie style house with a deeply overhanging low hipped roof. The mass of the house is two stories with one-story wings. The horizontality is emphasized by the façade details, roof lines, and bands of windows.

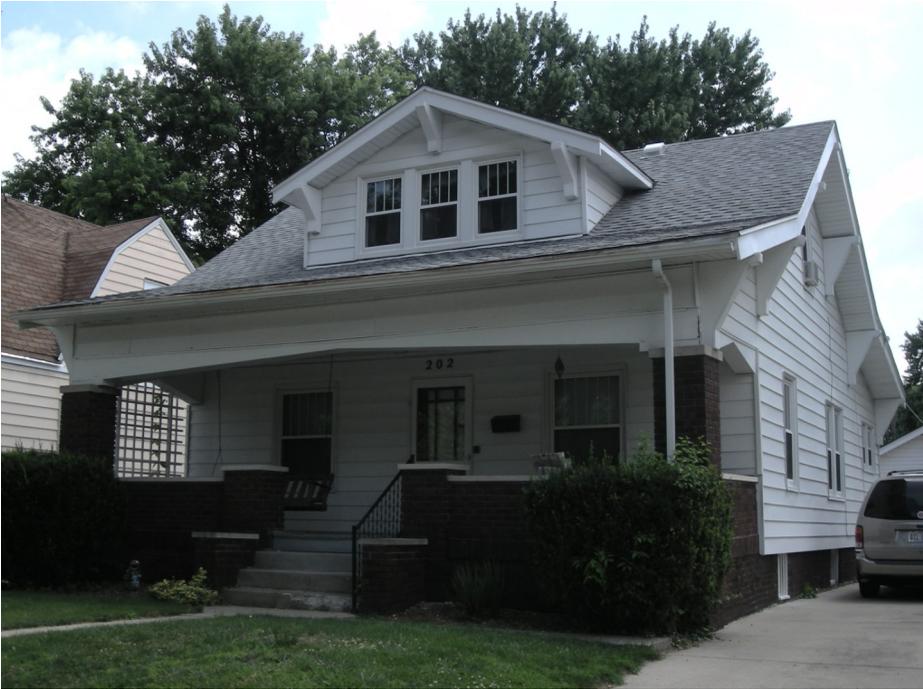
The bottom photo is of a “shed roof” Craftsman bungalow. The house has a side gable with a large front dormer. Simple brackets are located under the overhanging eaves of the gables. A full-width porch is supported by square columns that do not break at the porch level. The shed roof bungalow was very popular and variations of this subtype are common.

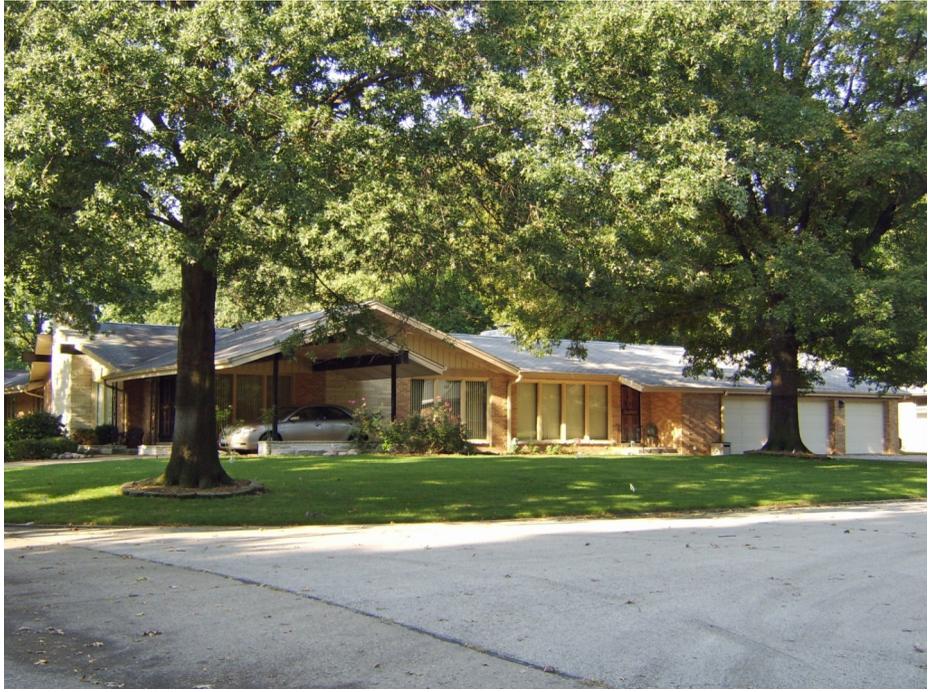
The bottom photo is of a Ranch house with a moderately-pitched hipped roof with wide overhanging eaves. The asymmetrical façade is emphasized by a bay window and changes in the wall depth. Decorative iron elements support the porch roof over the front door.

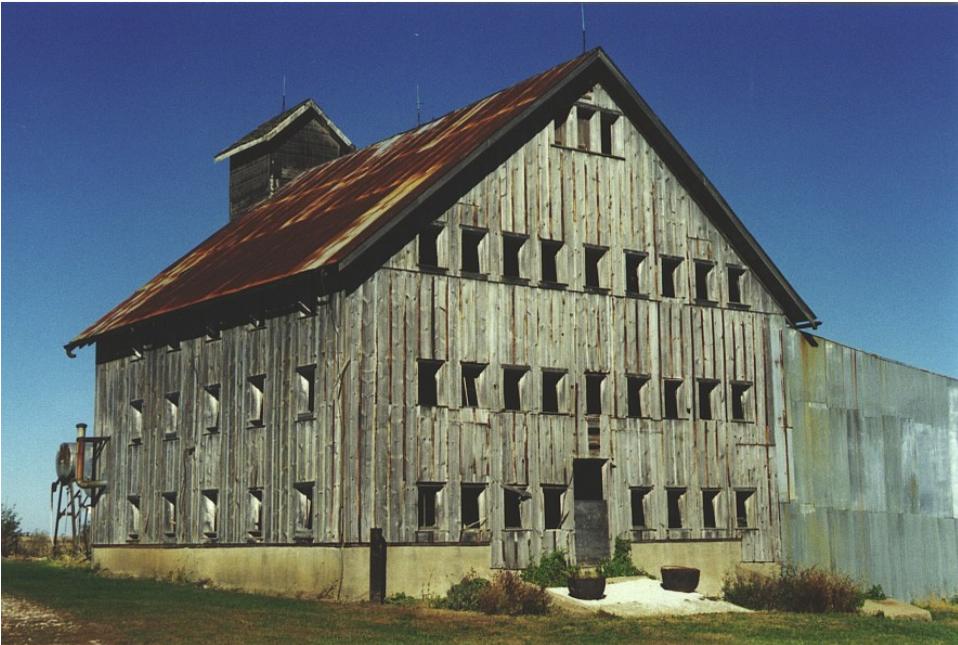
Historic barn

All round barns and most other types of wood barns are considered historic. Photos of pole barns, corrugated metal structures, fiberglass clad structures, and other modern structures are not required.

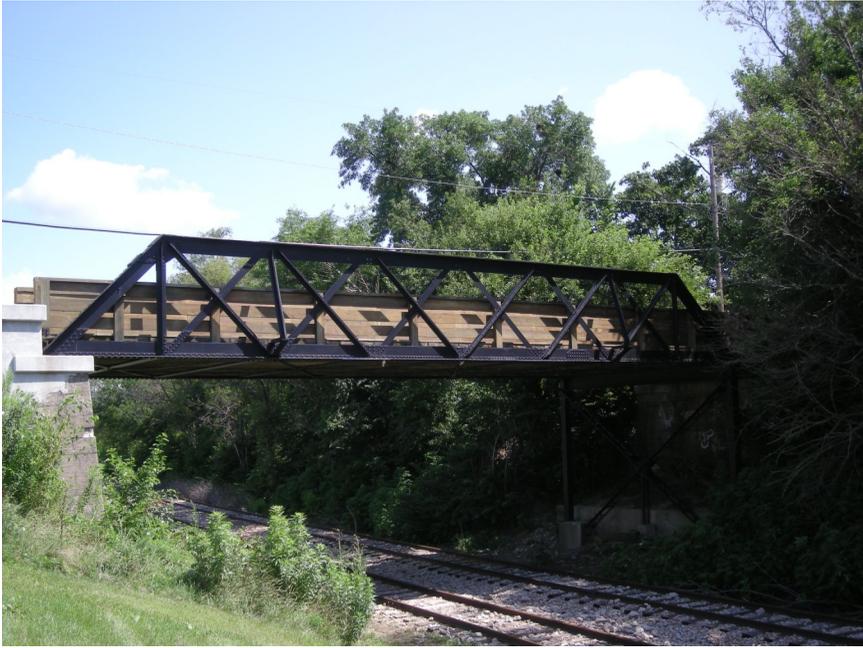
Steel Truss, Quadrangular Warren bridge

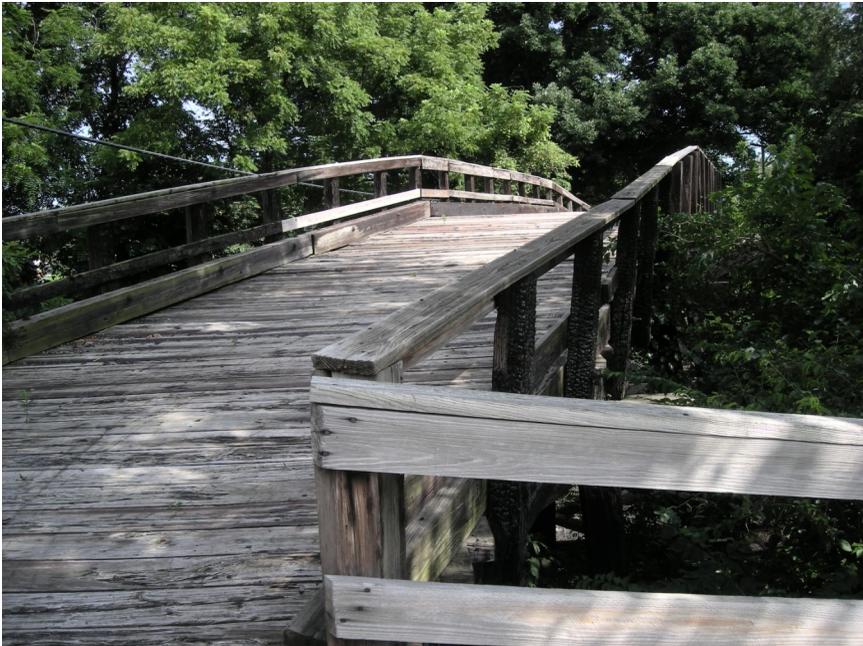
Timber Stringer bridge

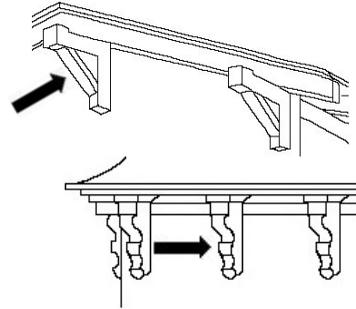
**Bracket:** A support element under eaves, balconies, windows, and other overhanging elements; often more decorative than functional

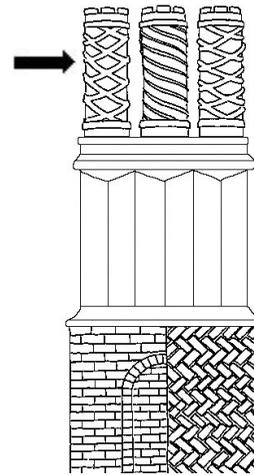
**Chimney Pot:** A pipe placed on top of a chimney that functions as a continuation of the flue and improves the draft

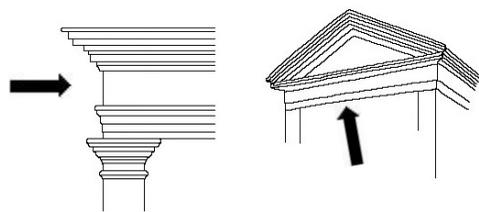
**Cornice:** In classical architecture, projecting ornamental molding along the top of a building or wall

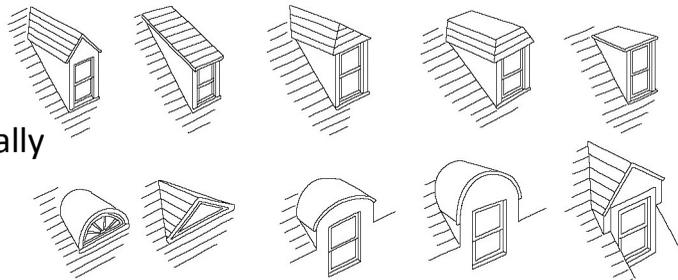
**Dormer:** A vertically set window on a sloping roof

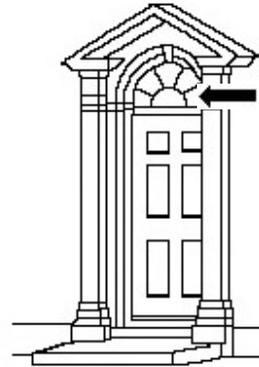
**Fanlight:** A semicircular or fan-shaped window with radiating members set over a door or window

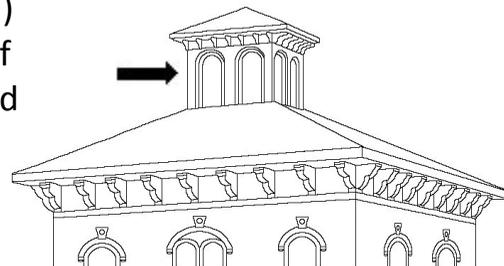
**Lantern:** (Also called a cupola)  
A structure built on the top of a roof with open or windowed walls

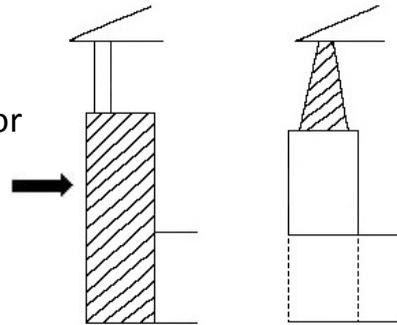
**Pedestal:** An architectural support or base for a column

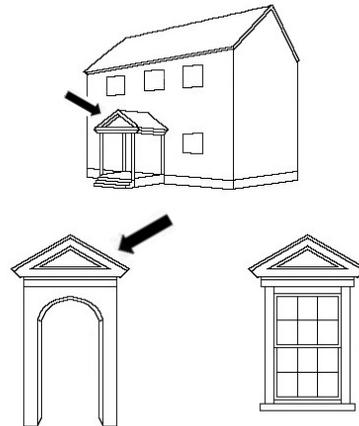
**Pediment:** A wide, low-pitched gable surmounting the façade of a classical style building; any similar triangular crowning element used over doors, windows, and niches

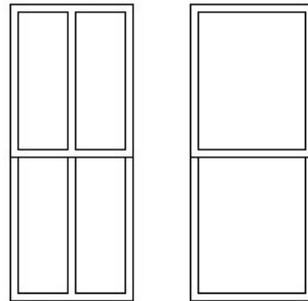
**Sash:** A frame in which the panes of a window are set

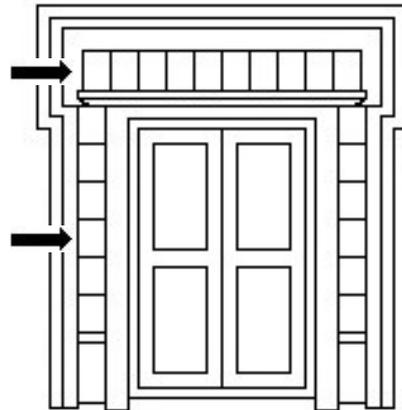
**Transom:** Horizontal window immediately over a door, often accompanied by sidelights

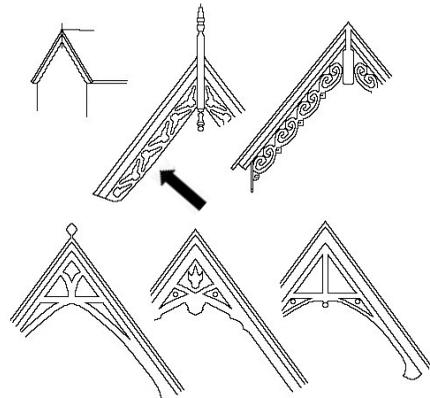
**Vergeboard:** (Also called bargeboard) Ornamental gable trim which is often richly decorated with carved, cutout, or painted designs and patterns
